Wing Nut Lugs Repair

MSI Technical Bulletin 045

Subject: Minimum allowance for use and repair of lugs on wing nuts.

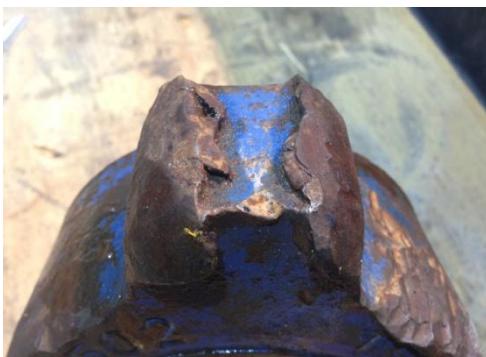
Figure 1

The first step in assessing the damage is visual. If material on any of the lugs has deformed to the point of extending over and rounding off the top of the lugs such that there is no longer enough undamaged material to strike the lug normal to the lug face, then the wing nut is beyond repair and should be scrapped. This applies even if the deformed material is only on one side of the lug. Refer to figure 1. Also, if extensive corrosion, erosion, or wear can be seen and such defects are to the extent that the function of the lug may be impeded, then the wing nut should be scrapped.
